Inspection:

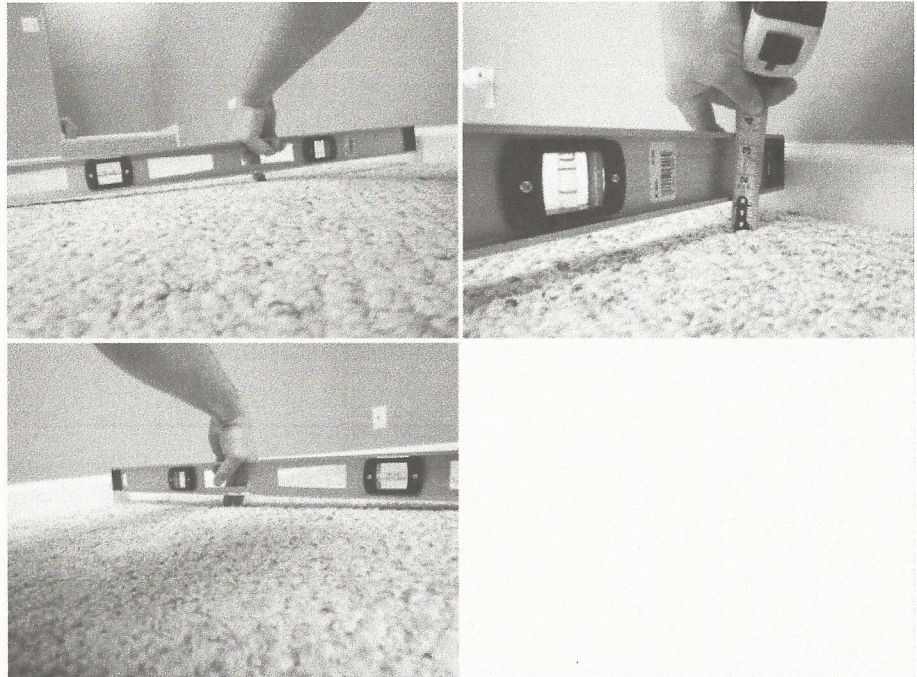
**Type:** Concrete.  
**Condition:** The concrete floor has settled approximately 1" to 1 1/8" on the N wall of the basement. There clearly is a crack in the floor under the carpet about 4' out from the wall. A similar crack with the floor settling approximately 1/2" to 3/4" was observed on the E and S walls of that same room and utility room. In the large bathroom, the concrete floor has a crack running E to W down almost the entire length of the room. The floor slopes towards the sink and toilet, then on the other side of the crack slopes towards the S foundation wall.

The cause of this is either the foundation has settled or the soil was frozen wet when the concrete was poured then heaved. It could be a combination of the 2. The foundation definitely has settled as the floor in the living room on the main floor from the doorway between the Dining Room and the Living Room to the N wall drops 1 1/2". I didn't notice any foundation cracks, so it looks like the foundation has settled pretty evenly and the posts and beam in the center of the house didn't settle.

Along N wall of basement

If you're not comfortable with the floors sloping this much, then recommend having a licensed Flatwork Concrete Contractor review and correct as deemed necessary.

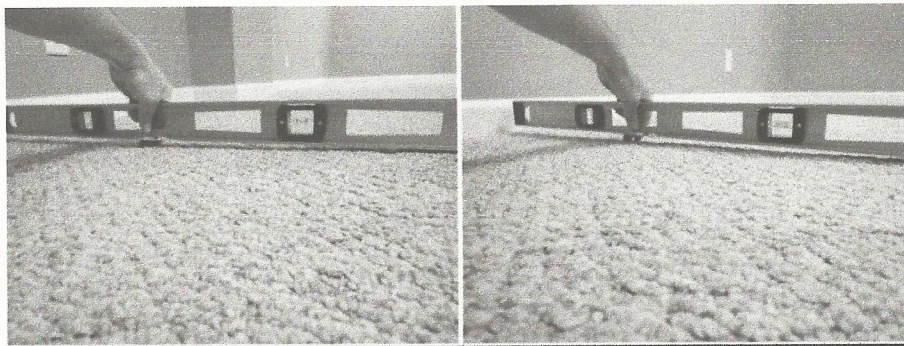
Along E wall of basement

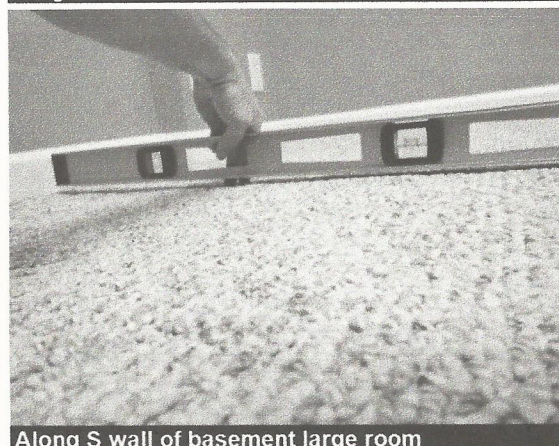
Along S wall of basement large room

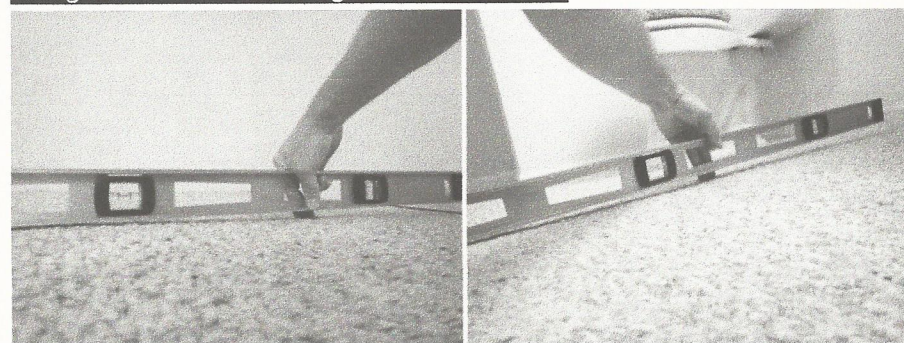
Along S wall bathroom, then N wall

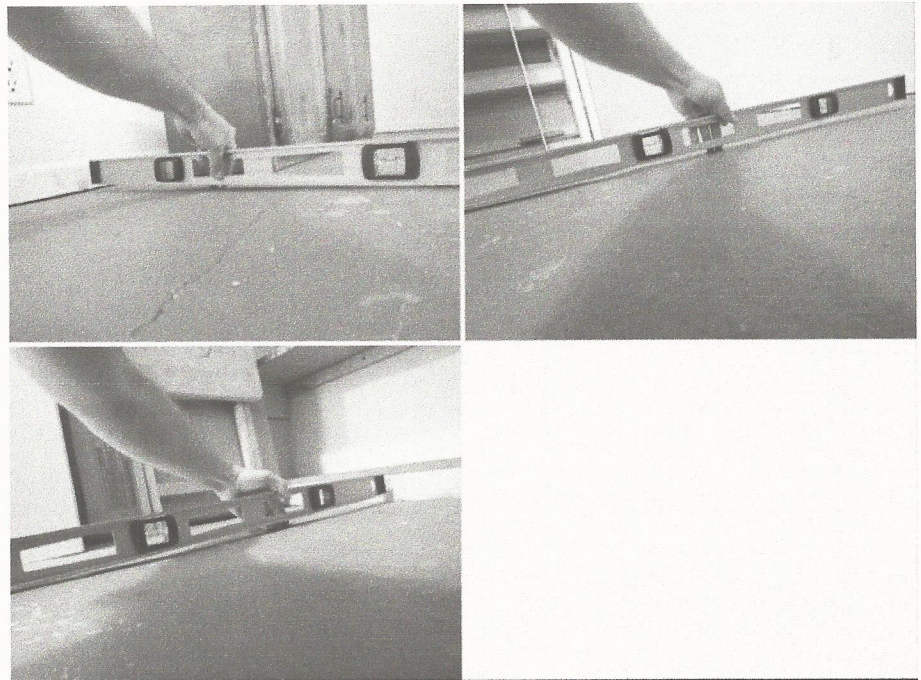
S, N, & W walls by sump pit

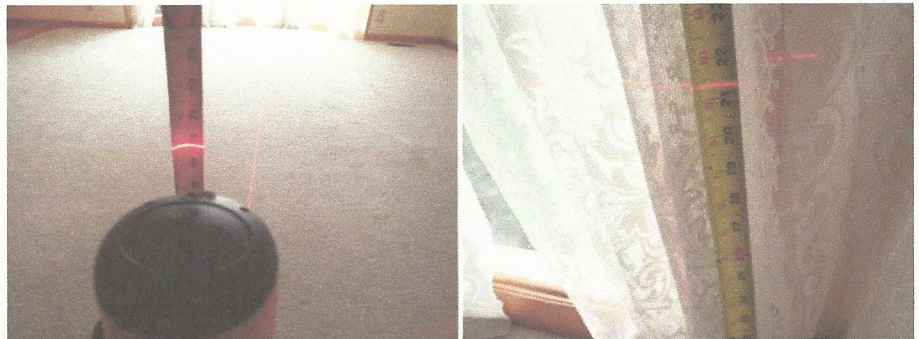
The living room floor and front entry where the wood floor is drops approximately 1 1/2" from S to N over 13'6". I can't predict if any further movement will occur, but it has had the test of time of 22 years. I doubt this will settle much further. It'd be best to have a licensed Structural Engineer review and if repairs are needed to have them oversee any repairs by a licensed Foundation Contractor. Worst case scenario would be to install a piercing system that would hydraulically lift the foundation back into position and level the floor. If you chose this option, you definitely want to get estimates because it's not cheap. Whether you are ok with this amount of settlement or want it fixed, that is your call. I've seen worse, but it's not my money.

Living Room drops 1 1/2" across 13'6" N-S
