Inspection: [REDACTED]

Address: [REDACTED]

Electrical System

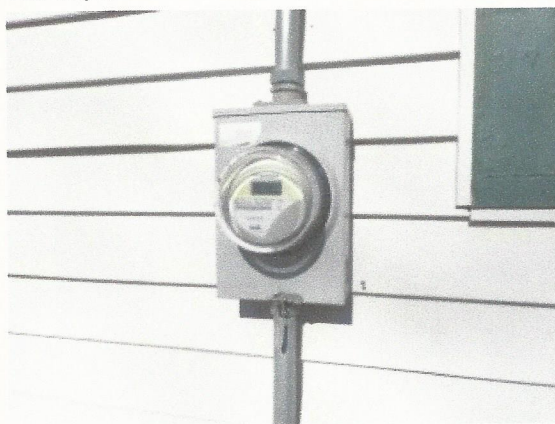
The meter box appeared to be plumb and in good condition.

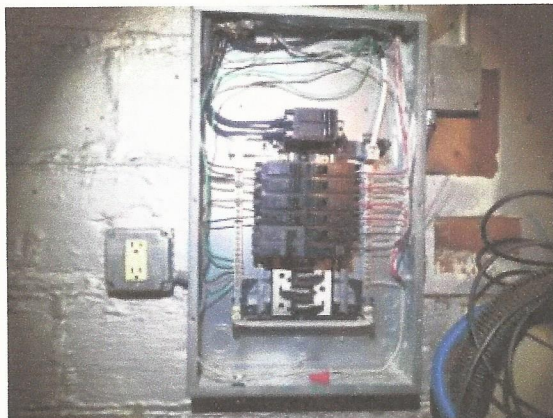
Condition: No significant issues observed. This main panel appeared to be in good condition and properly installed.

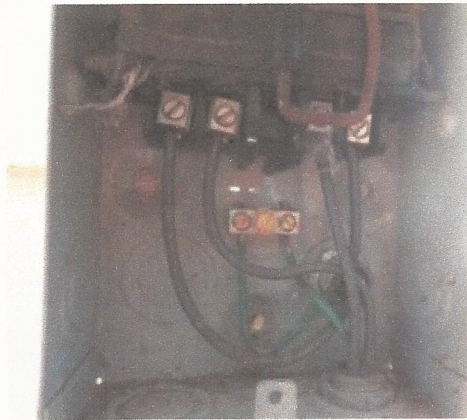
Condition: No significant issues observed. This sub panel appeared to be in good condition and properly installed.

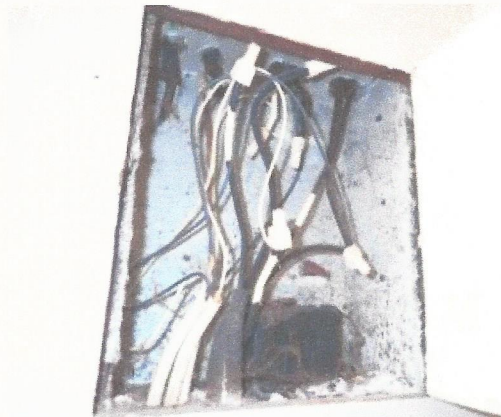
Asbestos Raceway by back door

Condition: The raceway used to be where the main panel was. It has been converted to a raceway. There is no metal cabinet where the spliced wires now run. It is asbestos with a wood door panel. This is a fire hazard and hazard because of the asbestos.

Before a licensed Electrician will work on this area, an Asbestos Abatement Contractor will need to properly remove the asbestos. If an Electrician removes the asbestos without proper precautions, they can be held liable for asbestos contamination.

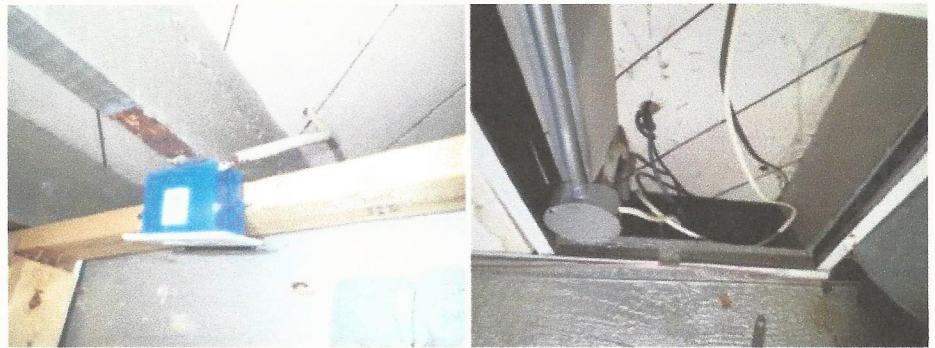
Basement Wiring: There is unprotected wiring below 8' in the basement. This is an electrical hazard. This wiring can either be protected by covering over it with drywall or some other acceptable material or have a licensed Electrician re-run it all in conduit.

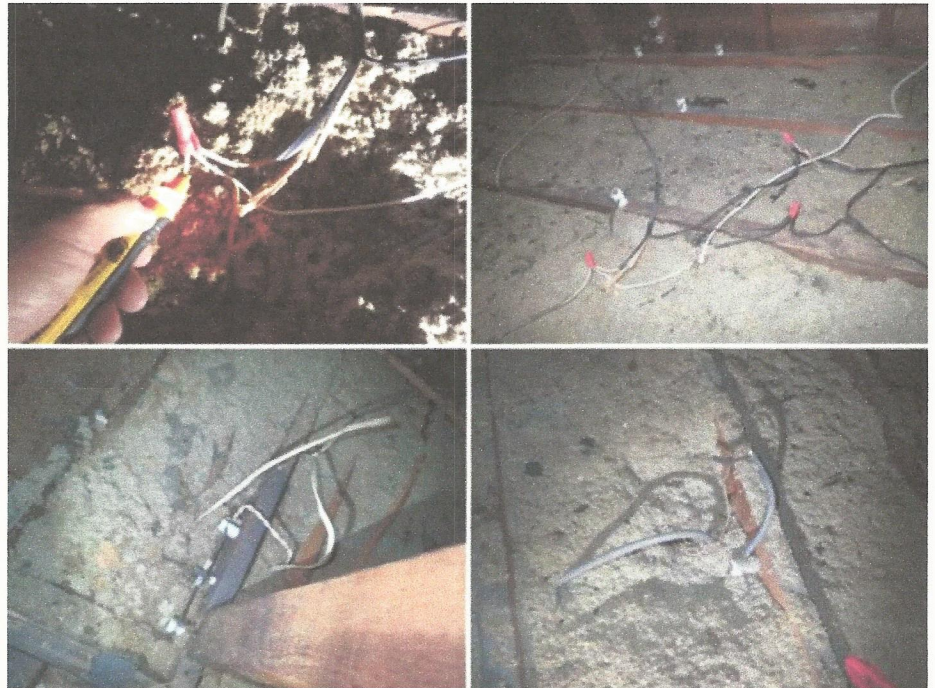
Live knob-n-tube wiring is present and it's been spliced onto. This old, out-of-date wiring can be a fire hazard. It needs 3" clearance so it doesn't overheat. Over time, the frail sheathing can become damaged or chewed exposing the live wiring. It is designed for only 15 amps and for the original wiring schematics of the home. This wiring shouldn't be added onto or spliced into as it can overload it. We recommend that this wiring be removed and replaced with Romex by a licensed Electrician as they deem necessary.
