Inspection: [REDACTED] Address: [REDACTED]

## Basement/Crawlspace

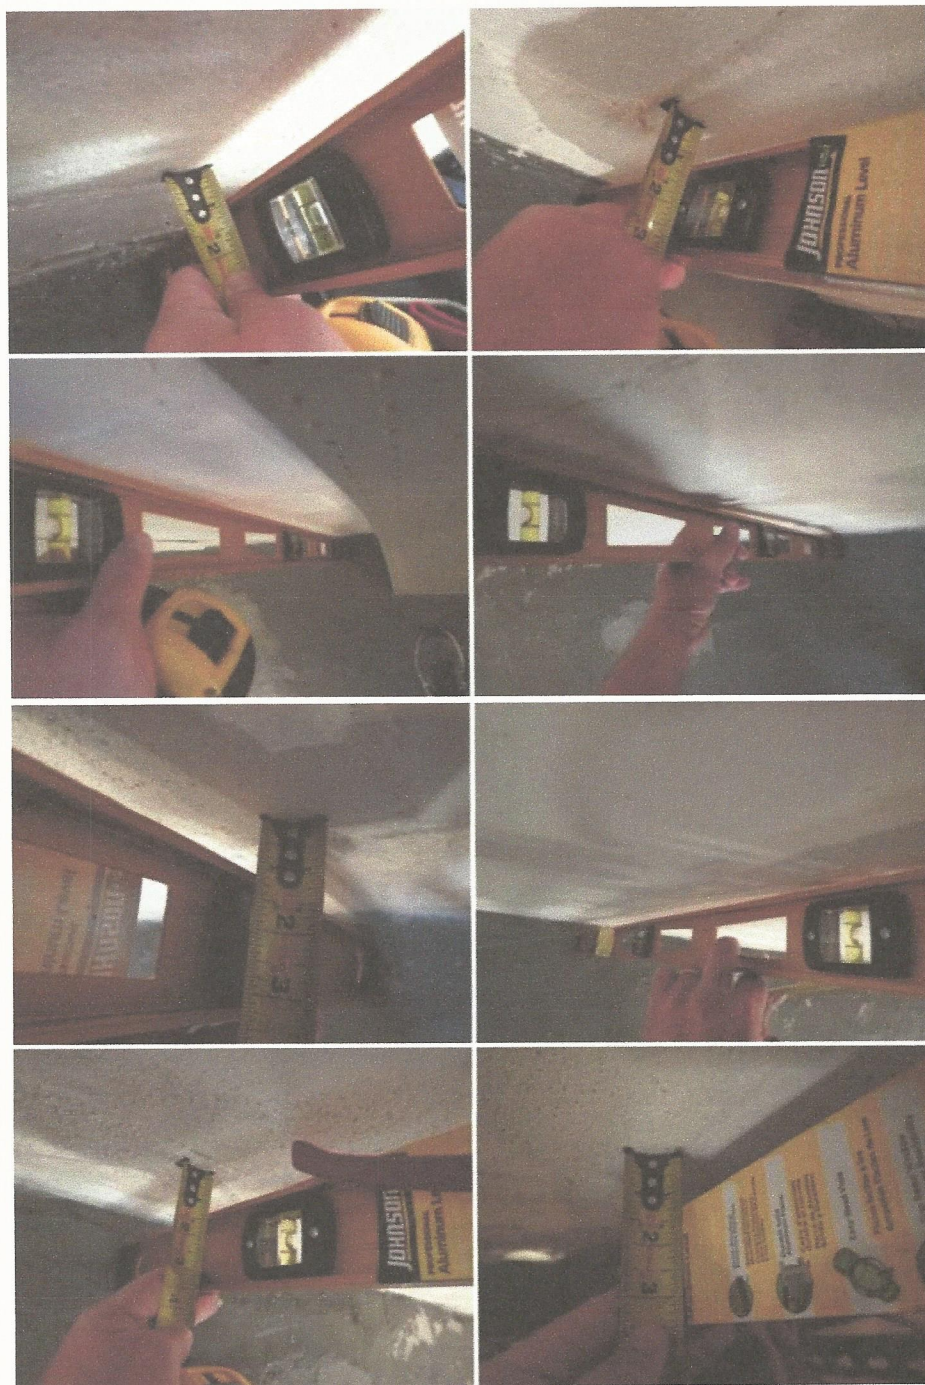
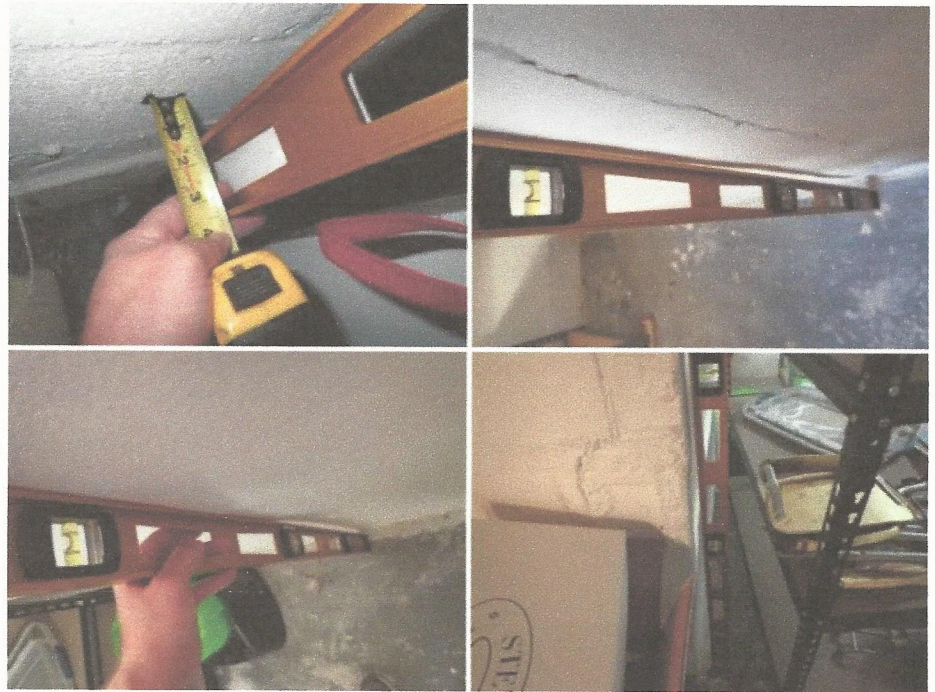
All 4 basement walls bow inward. The left wall has 4 vertical steel beams installed to help stabilize the wall, but there are additional areas that are leaning that are not stabilized. There is also another vertical beam in the back right corner of the addition, but the walls around it also lean and do not have vertical beams. The left wall at the window still bows inward 7/8", the back wall at the other window bows inward 7/8", the left wall towards the front of the house bows inward approximately 3/4", the front wall bows inward approximately 1", the right wall bows inward 1 1/4", and the addition walls under the back dining room bow inward approximately 1 1/2". When foundation walls bow inward more than 1", the general rule of thumb is to defer to a licensed Structural Engineer.

Recommend having a licensed Structural Engineer oversee any repairs by a licensed Foundation Contractor as deemed necessary.
