Inspection: [REDACTED] Address: [REDACTED]

Interior

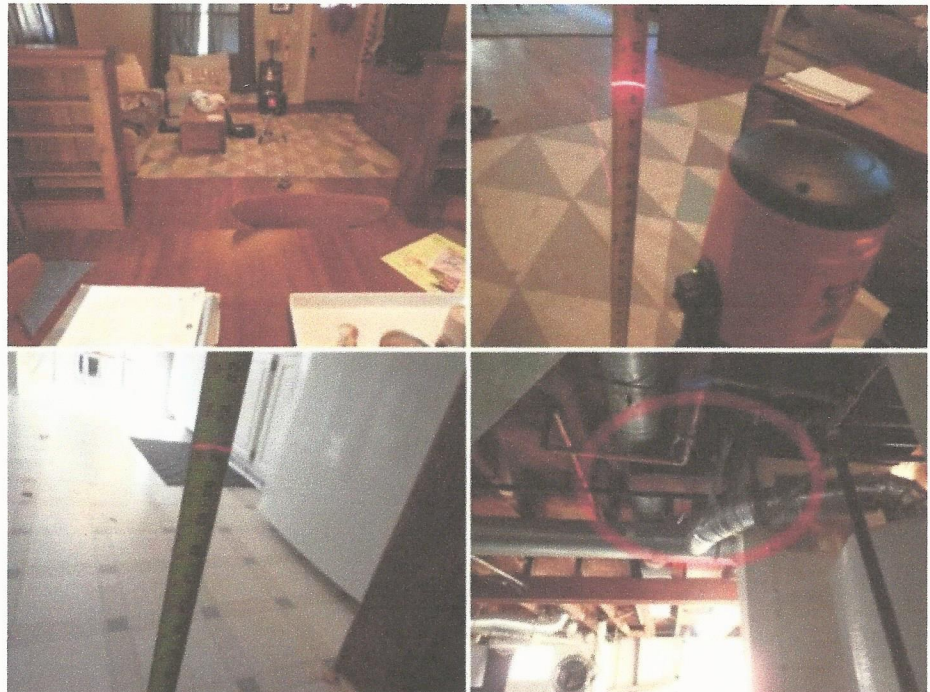
The header between the living room and dining room sags. This tells me that it's undersized. Someone has patched the drywall because there was no signs of cracking found.

Recommend having a licensed Contractor review and correct by installing a properly sized header over this large doorway.
