Inspecting Composite Wood Siding

Rick Bunzel, CRI

Pacific Crest Inspections, LLC

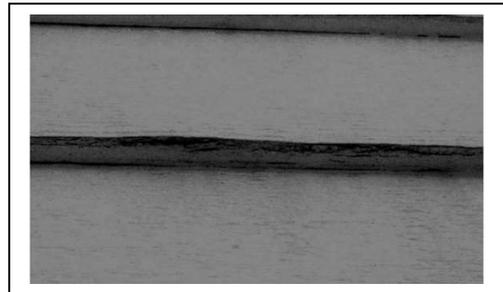
Edge Checking is found at the bottom edge of the siding. In some cases it looks like a stack of business cards view from the side. If you insert a probe into a "check" more than 1/8", the area is considered a "checked edge."

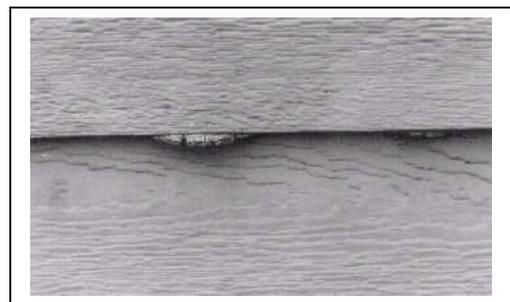
Fungi or mushrooms are the fruiting bodies of fungus. When fungi have reached the mushroom stage, it's well established in the siding. As it eats the nutrients it will move from one board to another. The sheathing may also be involved so the only sure way to determine the extent is to have a contractor remove the affected siding.

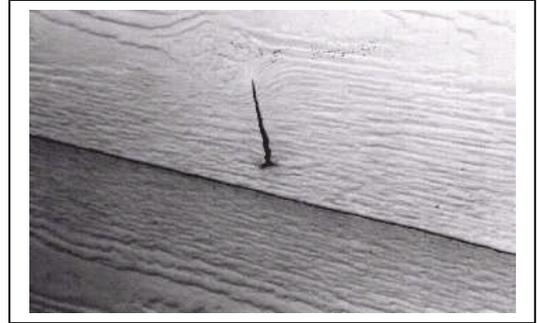
Wafer pops are unique to OSB and occur when strands are folded in the manufacture process and moisture exposure causes them to “unfold” through the top layer.
