Inspection: [REDACTED] Address: [REDACTED]

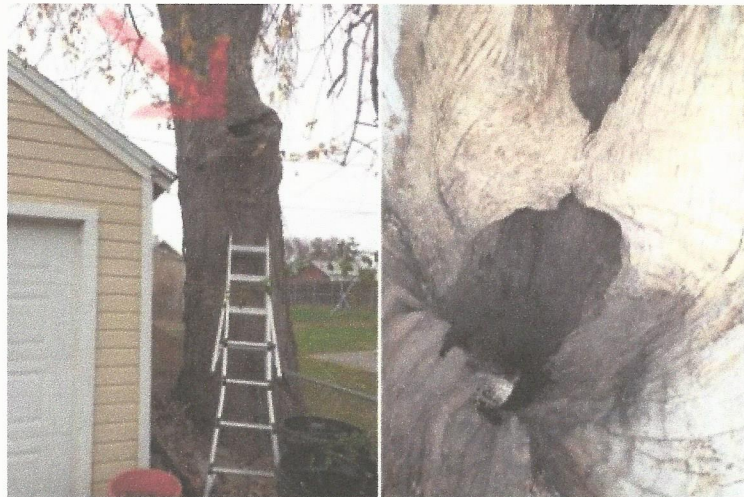
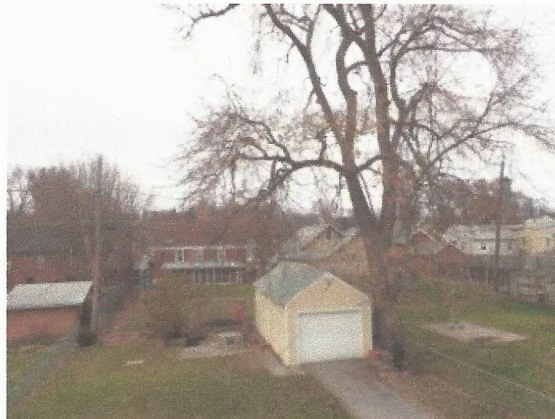
Trees: There is a large Maple tree growing along the side of the detached 1-car garage. The tree is growing up through the center where the chain link fence runs so it may be on both this property and the neighboring E property. There is a limb that fell off years ago with a hole in the tree. I put a ladder up to the tree and looked down into the hole. The entire trunk of the tree is hollow! This tree needs to be removed. It is at risk of falling on the garage or 2 sets of power lines in the back yard...1 along the back lot line and 1 along the W lot line. Not to mention, there is overhead power running from the house to the garage. However this tree falls, it can do a lot of damage. The picture inside the trunk is looking down the hole 10' above the ground down to the base.

Recommendation(s): Recommend having a Professional Tree Service carefully remove the tree.
