Inspection: [REDACTED] Address: [REDACTED]

Trees

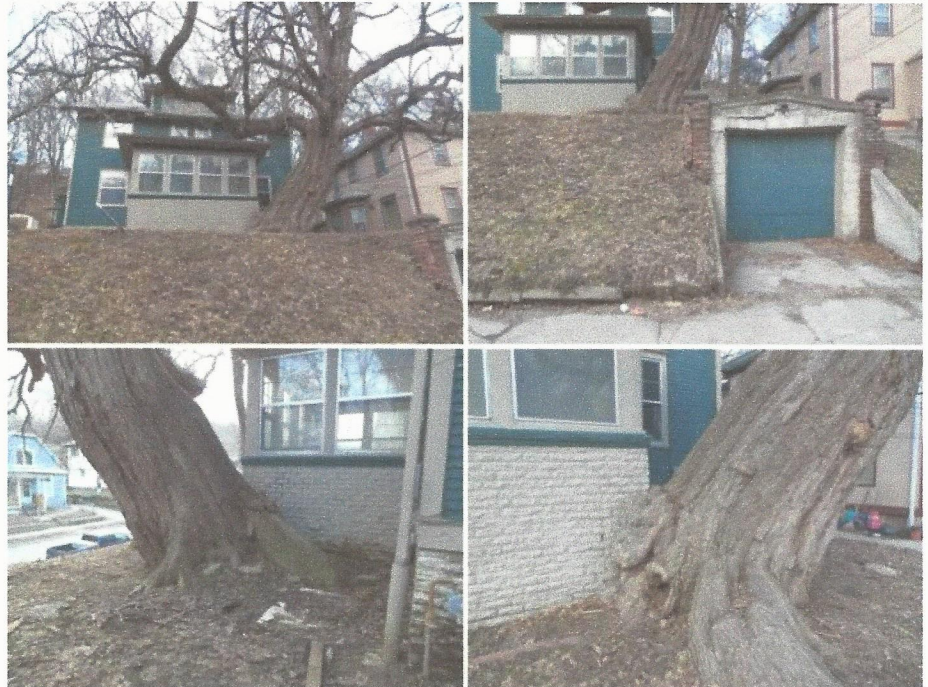
There is a massive tree in the front right corner of the front porch. The base measured more than 6' across and it's growing into the brick foundation in that corner. It's pushing the brick foundation in along the front wall of the basement in the front right corner. The garage was locked, but the left wall is clearly being pushed inward by the tree. This massive tree is way too close to the house and the garage, thus all of the damage to the foundations. The front porch has been lifted by the growth of the tree and the roof over it is now flat instead of having a low pitch to it. I could see where the water sits on the rolled roofing. Presently, some limbs overhang the house and there are branches rubbing the shingles bare. There are power lines that run along the front of this house near the tree.

When this tree is removed, the foundations will need to be repaired. I also question the condition of the sewer line out to the street as it runs out somewhere where the tree is.

Recommend having a Professional Tree Service remove the entire tree, including the stump, have a licensed Foundation Contractor replace these areas of the foundation making sure the front porch has a slight slope to it and lifting the entire right foundation wall of the house back so the main floor is level. Presently, the floors drop 1" on a 4' span along the entire wall in the Formal Dining Room and Living Room.
